Drainage Inspection Along Railroad Village of Peoria Heights

On March 13, 2008 Mark Allen, Mayor, Bob Roth, Public Works Director, and I (Dan Good, Devonshire Randolph Engineering) performed a drainage inspection of the railroad area as follows: 1) from Glen Avenue toward the northwest to approximately the southeast end of Humboldt Ave., and 2) from Prospect Road at Marietta Ave. toward the southeast to approximately Miller Avenue. The results of this inspection are summarized below.

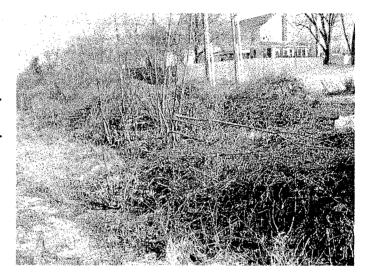
East side of railroad tracks

Brush in the ditch line is restricting proper drainage.

Standing water was observed in some locations.
 Brush should be removed to restore normal flow path.

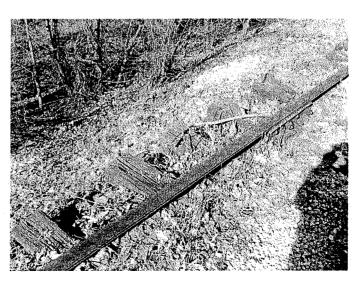
West side of railroad tracks

Erosion has occurred under end of railroad ties.

Additional gravel should be placed under the ties and the area stabilized to prevent further drainage problems.

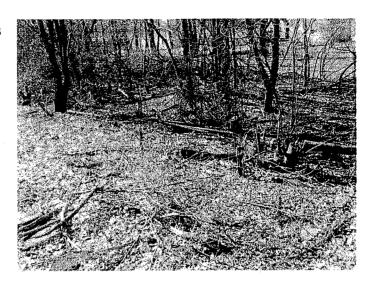
West side of railroad tracks

In general old railroad ties and rails are lying along the bank. In some cases they are located in the ditch, which restricts proper drainage. Railroad ties and rails should be removed.

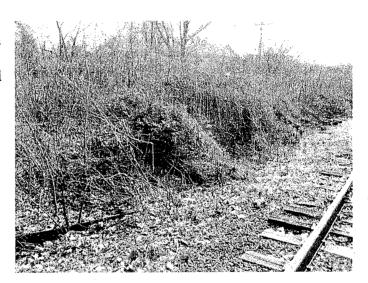
East side of railroad tracks
 Brush is lying in the ditch line restricting normal drainage. The brush should be removed from the area.

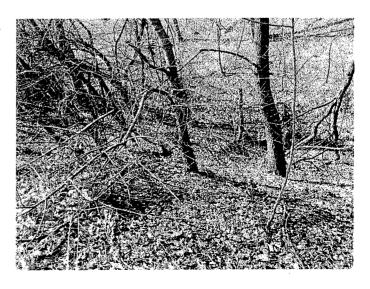
West side of railroad tracks

The steep bank at the storm sewer crossing has potential erosion/stability concerns. Bank should be investigated and stabilized as needed.

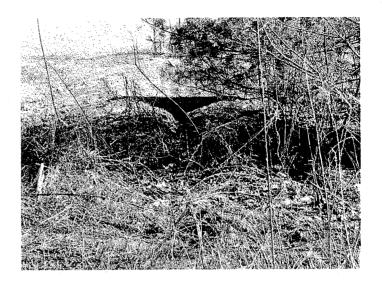
East side of railroad tracks

Village storm drain is backed up due to ditch blockage along railroad.
 Railroad ditch should be cleaned and graded to drain.

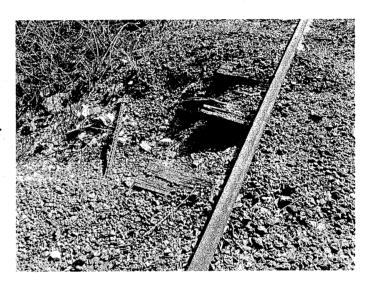
North side of railroad tracks -- Erosion has occurred under end of railroad ties. Additional gravel should be placed under the ties and the area stabilized to prevent further erosion.

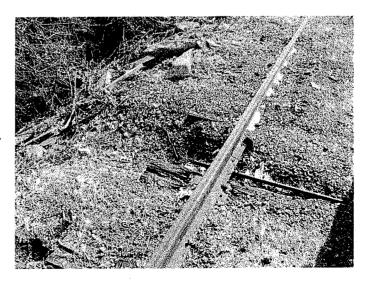
North side of railroad tracks -- Erosion has occurred under end of railroad ties. Additional gravel should be placed under the ties and the area stabilized to prevent further erosion.

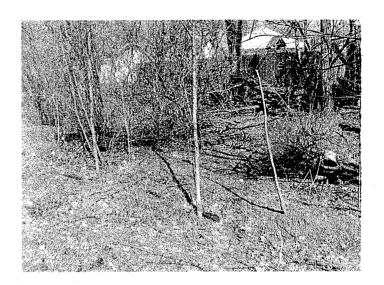
North side of railroad tracks – Ditch is poorly graded and covered with brush and debris, which inhibits proper drainage. The brush and debris should be removed. The ditch should be re-graded, as needed, to create good drainage.

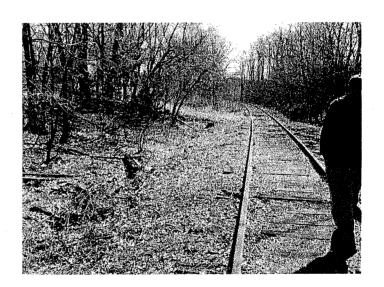
North side of railroad tracks – Brush in the ditch prevents proper drainage.
 The brush should be removed.

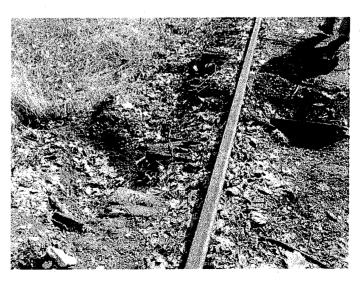
North side of railroad tracks – Erosion has occurred near the culvert. Gravel should be replaced and the bank properly shaped and stabilized.

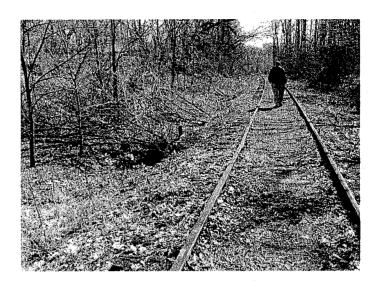
North side of railroad tracks – Brush in the ditch is restricting proper drainage. Brush should be removed.

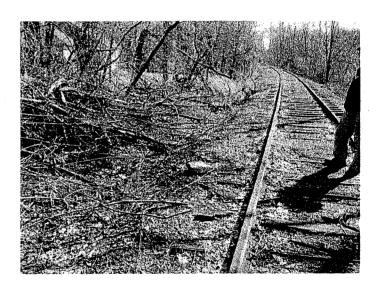
North side of railroad tracks – Brush in the ditch is restricting proper drainage. Brush should be removed.

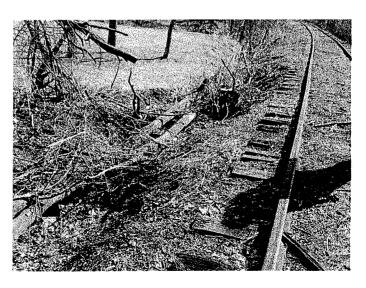
North side of railroad tracks – Brush in the ditch is restricting proper drainage. Brush should be removed.
